BNL 1

Bruker Nitrogen Liquefier

● User Manual

Version 05

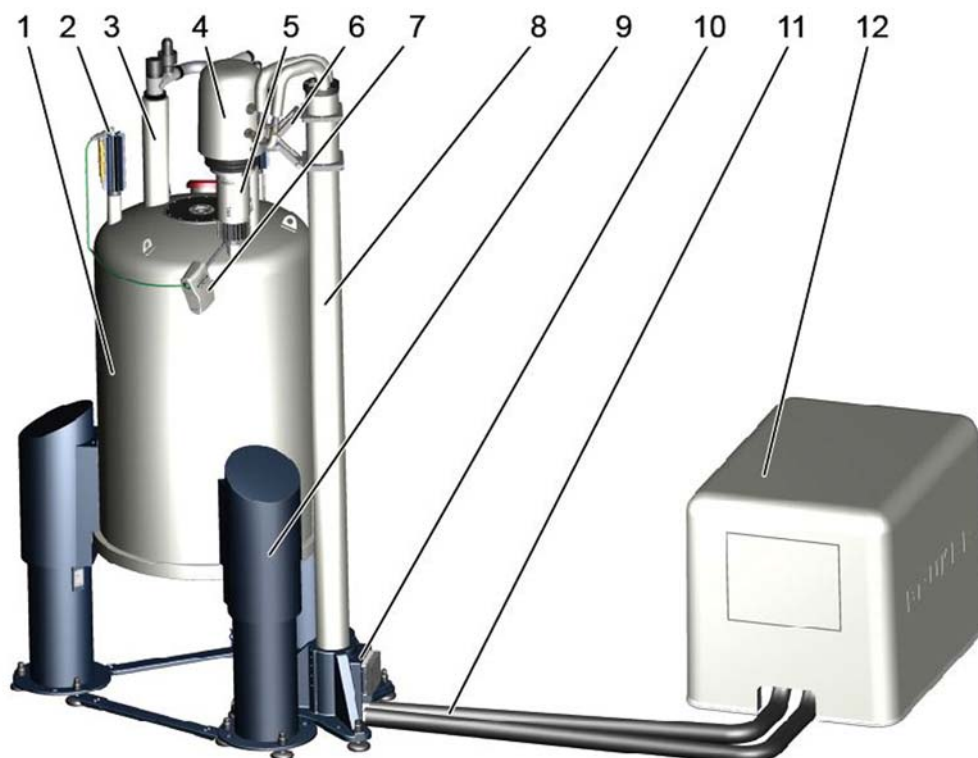
- 1 Magnet System
- 2 Nitrogen turrets (three or four possible)
- 3 Helium turrets (two or three possible)
- 4 Cold Head with noise protection cover
- 5 BNL case
- 6 BNL fixing unit
- 7 CMU (Cryostat Monitoring Unit)
- 8 BNL stand tube
- 9 Magnet Stand
- 10 BNL stand with JAC
- 11 Flex lines
- 12 Compressor (noise protection cover optionally)

Figure 1.1: General view of the Bruker Nitrogen Liquefier (BNL)

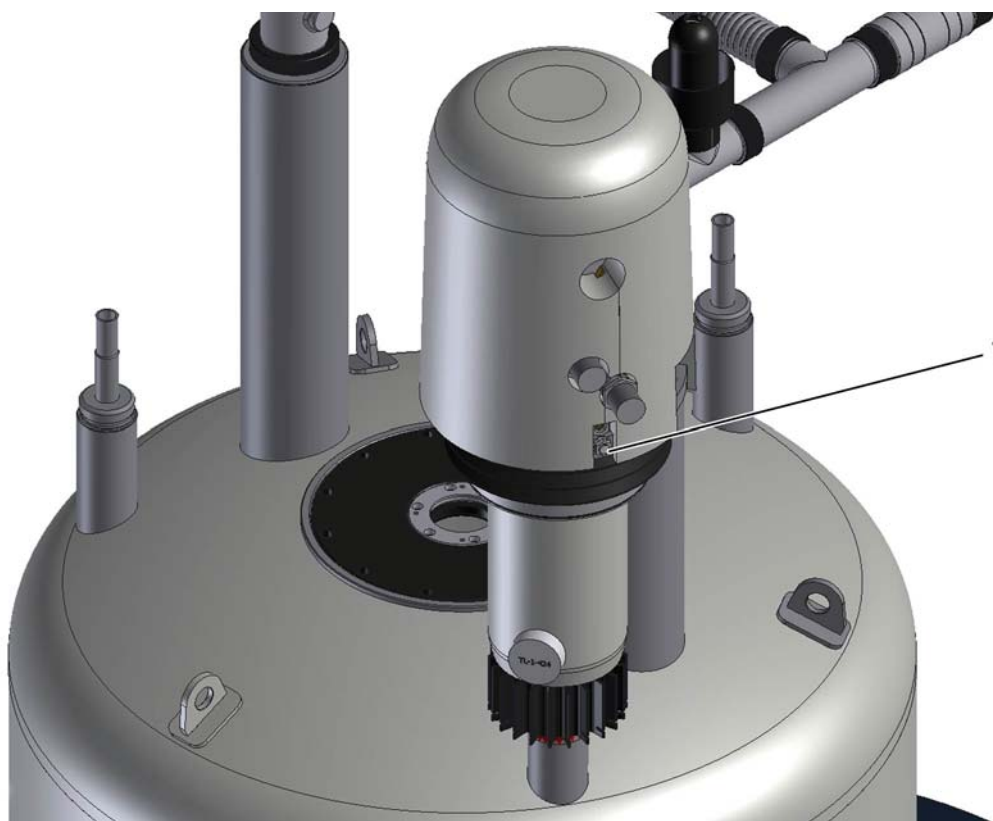
Figure 2.1: BNL safety device

Safety Valve

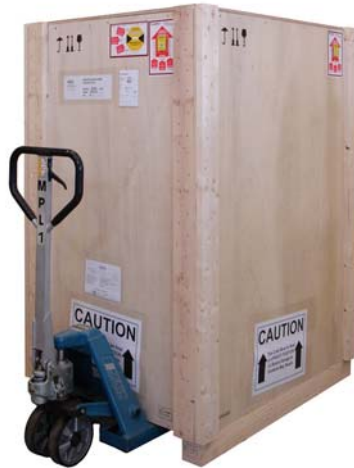
Figure 3.1: Transport by forklift – front side

1. Check the route of transport for the minimal height and width.
2. Check sufficient floor capacity on the route of transport. In case of doubt ask a stress analyst.
3. Check sufficient carrying capacity while using an elevator.
4. Position the forks between the bars of the crate as shown in the figure. Make sure the side towards the operator is the one with the labels on it.

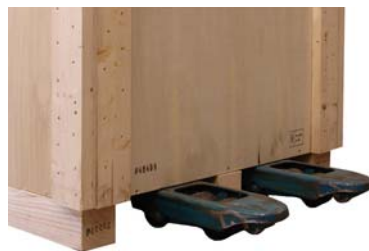
Figure 3.2: Transport by forklift – rear side

5. Make sure the forks of the forklift are longer than the crate and projects out at the back of the crate as shown in the figure.
6. Now lift the fork and move the crate to the site.

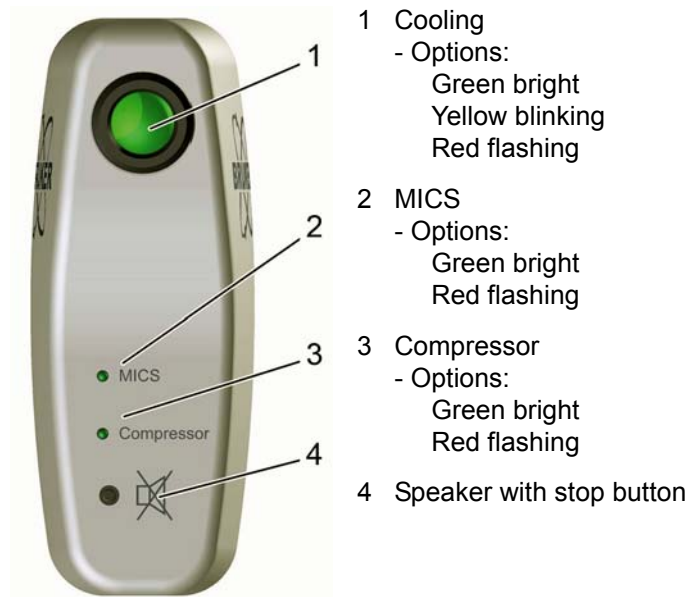
Figure 5.2: Interface of the CMU

- 1 Cooling
 - Options:
 - Green bright
 - Yellow blinking
 - Red flashing
- 2 MICS
 - Options:
 - Green bright
 - Red flashing
- 3 Compressor
 - Options:
 - Green bright
 - Red flashing
- 4 Speaker with stop button

The operating status of the BNL is displayed at the MICS and CMU. A bright green LED at the CMU displays the normal operation of the BNL. For any other light see chapter [During Standard Operation on page 42](#).

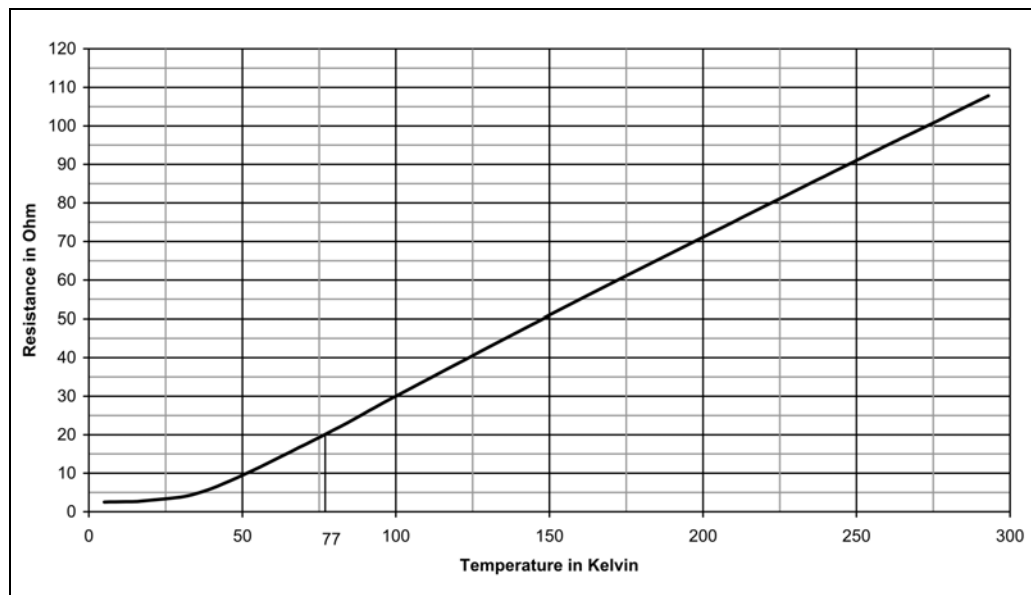
Figure 9.1: Characteristic Curve PT 100

Temperature	Unit	Resistance	Unit
Room Temperature	293	K	107.8	Ω
	273	K	100.0	Ω
	250	K	91.0	Ω
	200	K	71.1	Ω
	150	K	50.9	Ω
	100	K	30.0	Ω
Liquid Nitrogen	77	K	20.1	Ω
